Manhole Inspection Summary

Manhole # S19EE2008MH

Location Address: **5748 FALLS RD**

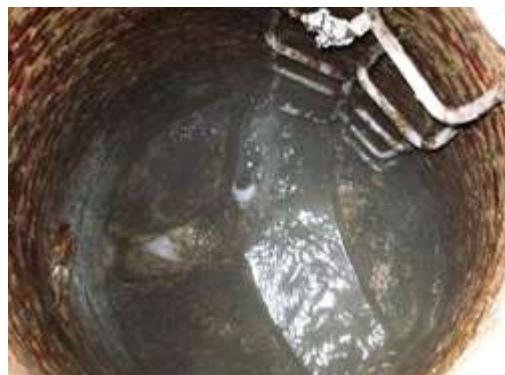
Top View

Evidence of surcharge - Bench debris.

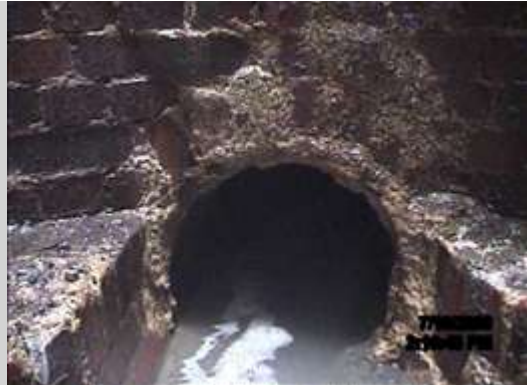
Pipe Out @ 12 O'Clock

15 in. Circular Gravity Sewer

Invert Depth: **18.40** (ft.) Flow Characteristics: **Fast**

Infiltration: **Evidence** Pipe Seal Cond: **Unknown**

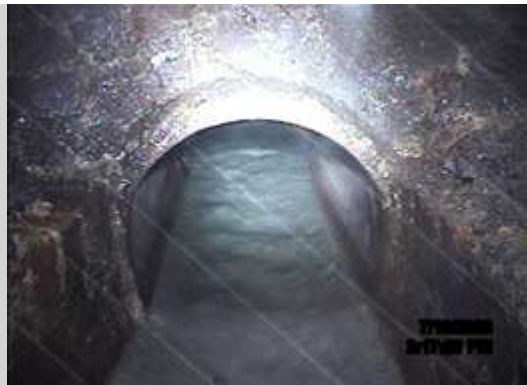
Pipe In @ 4 O'Clock

15 in. Circular Gravity Sewer

Invert Depth: **18.22** (ft.) Flow Characteristics: **Fast**

Infiltration: **Evidence** Pipe Seal Cond: **Unknown**

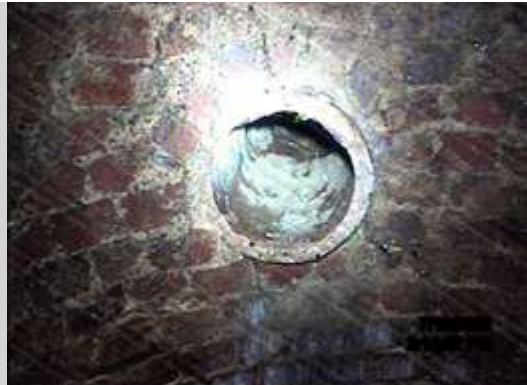
Pipe In @ 9 O'Clock

8 in. Circular Gravity Sewer

Deposits: ☐ None ☐ Mud ☐ Sludge ☐ Debris ☒ **Grease**

Silt Depth: **0** (in.) Deposits Extent: **Light**

Infiltration: **Evidence**

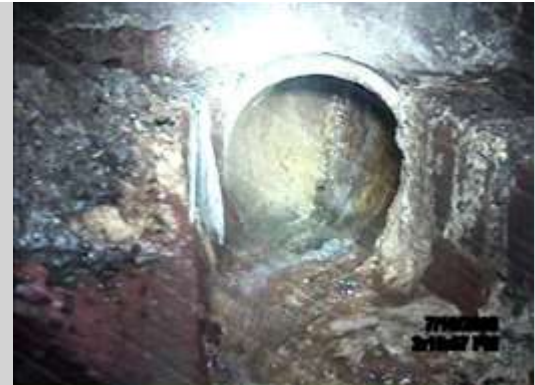
Drop In @ 9 O'Clock

Drop: **Outside** Rod and Bar

Angled: **Yes** Reading: **16.79** (ft.)

Inv Depth: **17.79** (ft.)

Drop Condition: **Open**
